Document #: DOC_PRD-1002
Origination Date: 8/22/07

Title: MHV & SHV High Voltage Test Procedure

Scope: This document describes the test procedure and results for the voltage rating verification of the coaxial MHV and SHV style high voltage connectors and associated end items. The ceramic to metal feedthrough portion of the connector is designed to mate with an industry standard MHV or SHV plug on the atmosphere side and to operate with a system pressure of not greater than 1×10^{-4} torr on the vacuum side.

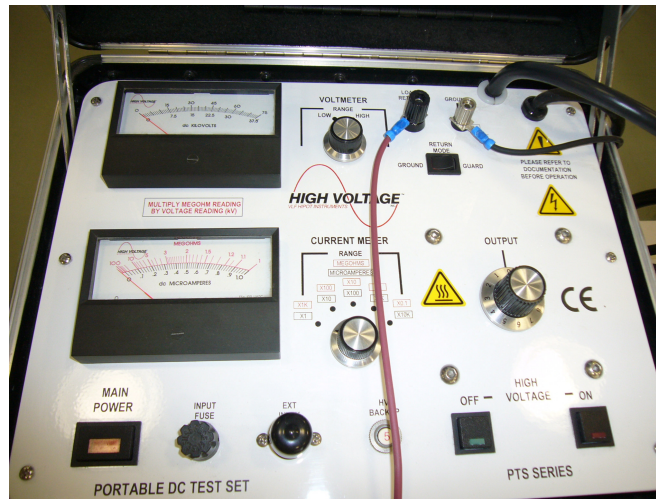
Figure 1: High Voltage DC test set

Equipment: Diffusion Pumped Hot wall Vacuum Furnace
 High Voltage Portable DC test set (see **Figure 1**)
 Granville Phillips 340 Vacuum Gauge Controller (see **Figure 2**)

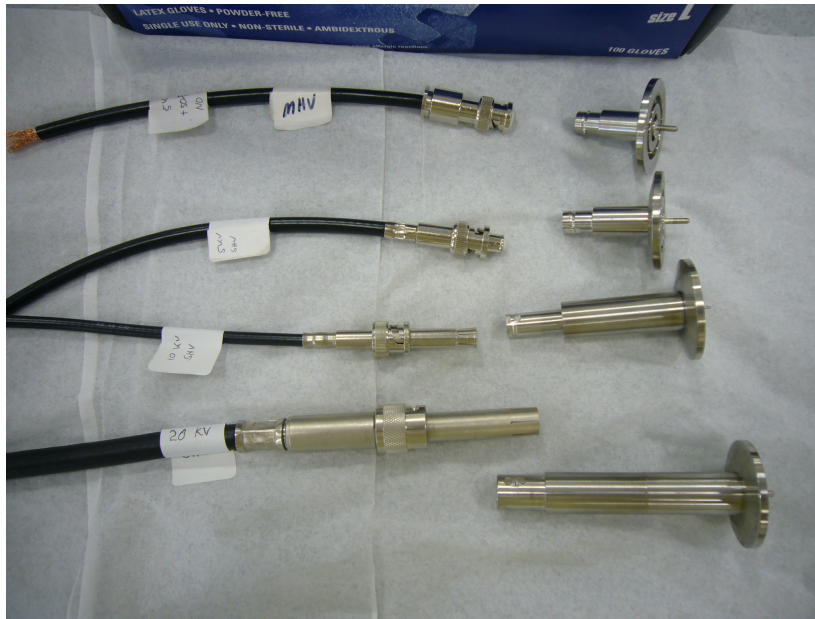
Figure 3: HV Receptacles with Plugs/Cables

1. Recessed versions of the MHV and SHV receptacles were welded into flanges for mounting on a vacuum system. The “recessed” versions were chosen because they have the shortest vacuum arc gap and would exhibit the worst case condition during electrical testing.
2. SST supplied plugs were outfitted with cables per assembly instructions. (see **Figure 3**) The “free” end of the cable was stripped back to accommodate the test voltage. The following cables were used:
